ROOF AUDIT

**3901 SE 29th Street
Made Up City, MO 123456**

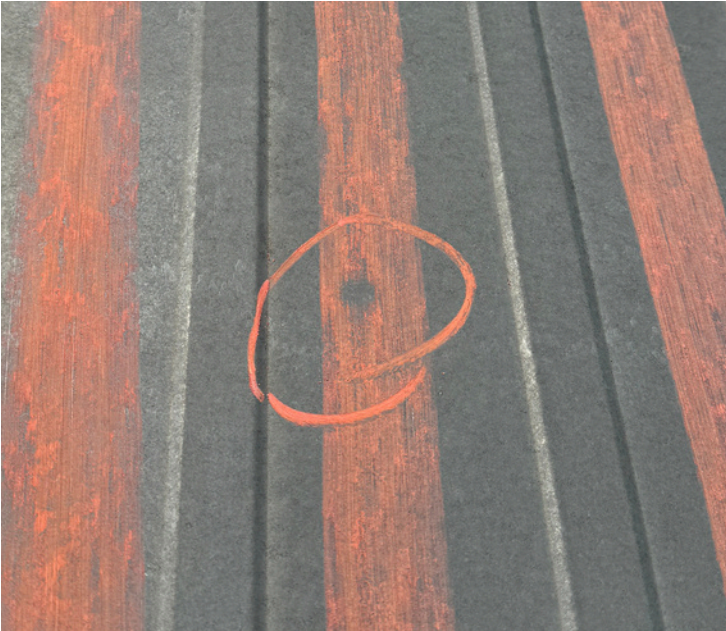
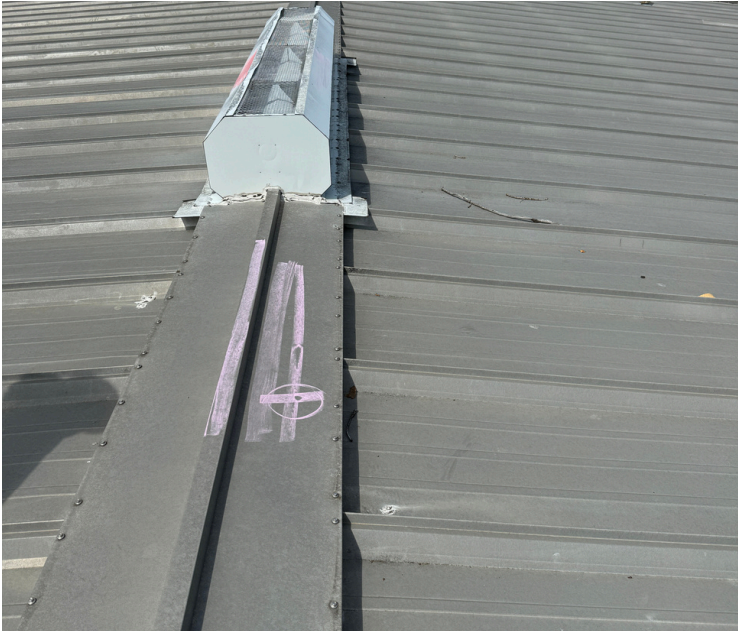
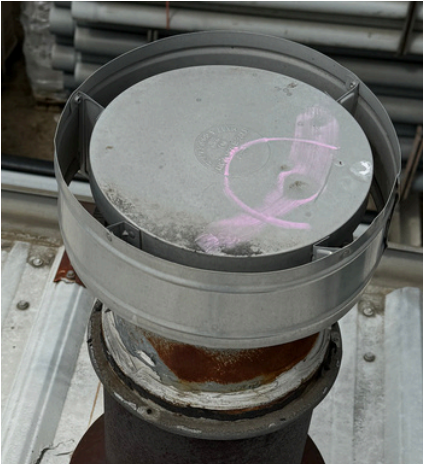
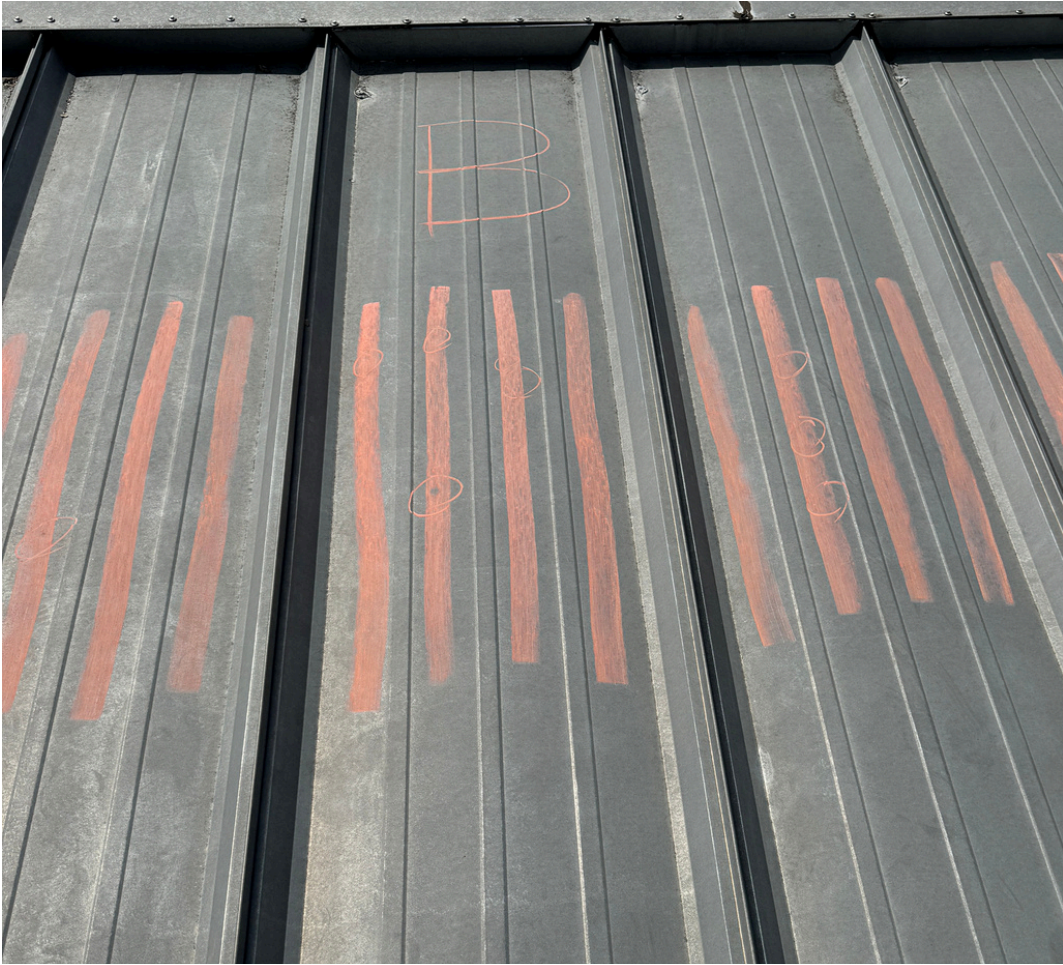
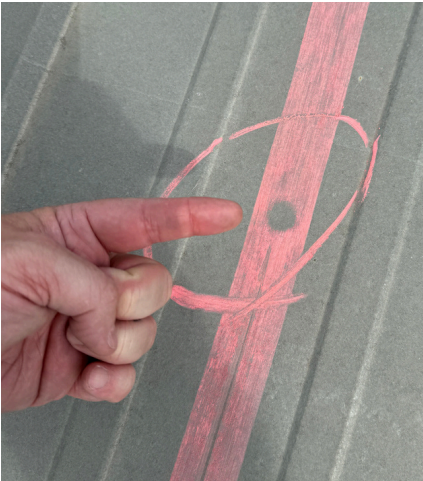
ROOF AUDIT PHOTOS

10/1/24 Upon inspection, we found the roof to have visible and significant hail damage from the multiple storms we've received in the OKC area in 2024.

Hail has left noticeable damage and appears as gorges, cracks and punctures. Metal material had divots caused by hail and needs restoration.

Being a Level 3, Roofing Company suggests a full roof replacement is required within 1-6 months.
